NAVWEPS 00-75-510

THE NAVAL AVIATION SAFETY REVIEW

FEBRUARY 1961

The Other Way to Stop	by LCDR R. W. Kennedy	
Introduction and Evaluation of the Aircraft Carrier Barricade.....		4
Anymouse		
Anonymous Incident Reports.....		14
Whiz Quiz		
Questions on Altimetry.....		17
Headmouse		
Technical Questions and Answers.....		18
Mountain Helicopter Flying	by LCDR Marion G. Shrode, USCG	20
Kelp!		
Pilot's Parachute Entanglement After Ejection into Water.....		24
Thrust Rating		26
Mighty Like A Rose		
Review of Aircraft Accidents and Incidents.....		28
Notes from the Flight Surgeon		30
Hell and High Water		
Ditching of a Skyraider (AD-6).....		32
Transient Service		
Transient Service at Naval Air Stations.....		34
Underboost—No Sweat!		
Helicopter Engine Operation.....	by LTJG R. M. Torick, HS-8	38
Latch Not—Hatch Not		
Helicopter Hatch and Window Losses, Prevention of.....		40
Topside Topics		
Safety Council Notes.....		44
Foreign Object Damage Prevention		46
Murphy's Law		
Reversal of Cannon Plugs.....		47

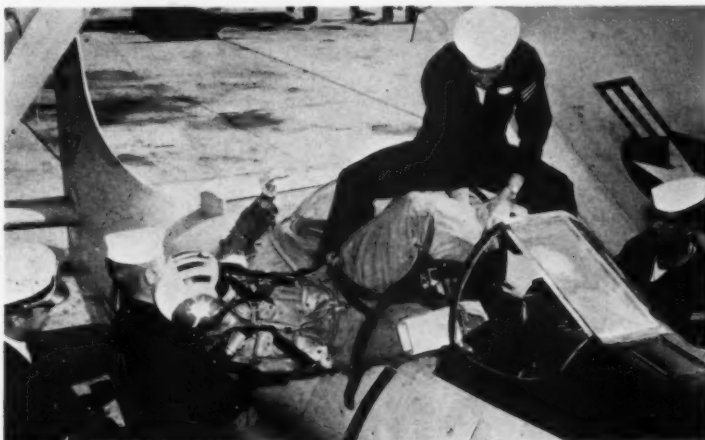
Plane guard destroyer men check out rescue teams in removing a fully outfitted pilot from cockpit of an AD.

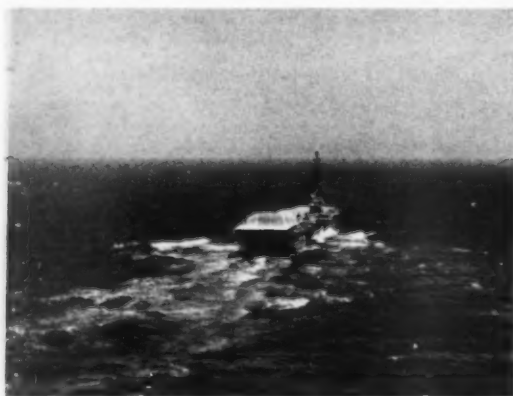
Pilot's-eye view of the barricade. Note two mirrors. Meatball is going . . . going . . .

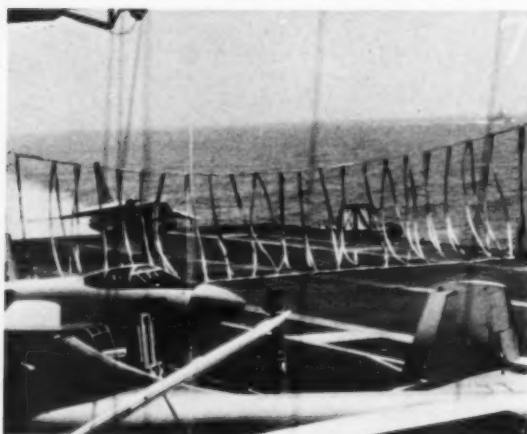
After centerline touchdown (above), nose collapses but barricade is engaged.

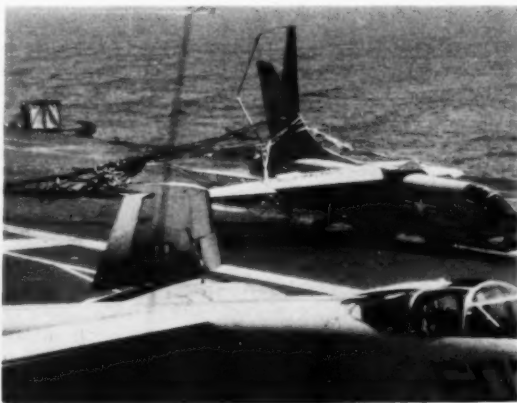
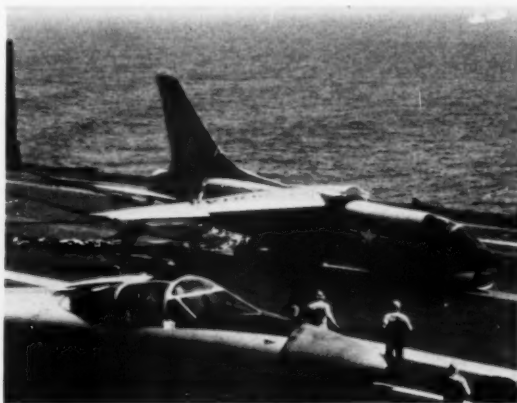
Bird comes to stop in tangled array of straps and cable.

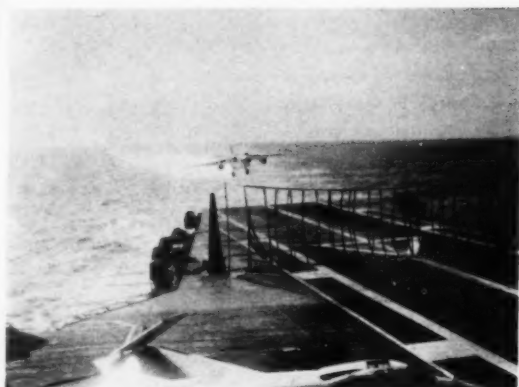
Big A3D boresights barricade. One main gear is unsafe and collapses.

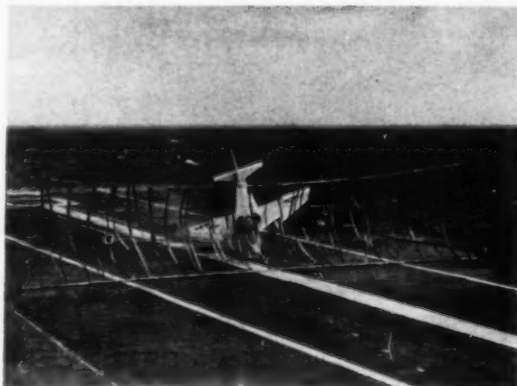
Starboard wheel stub engages number 1 wire. Hook is down but out of position to engage wire.

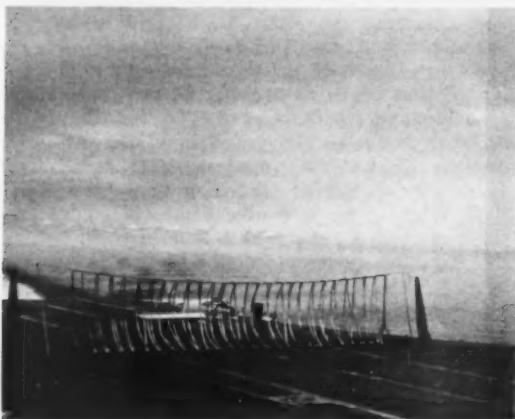
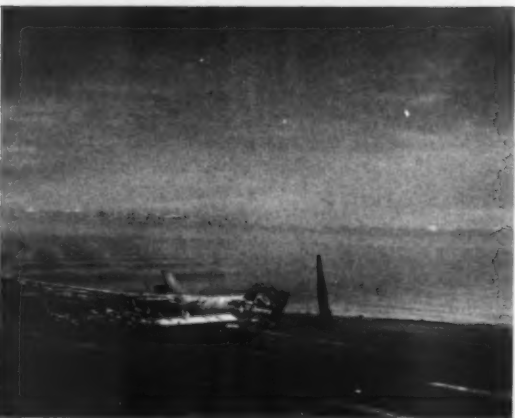
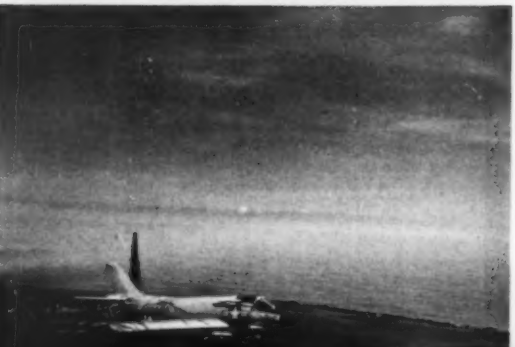
Barricade becomes solution for no backpoint and no-divert situation. Centerline, nosewheel on deck attitude aids outcome.

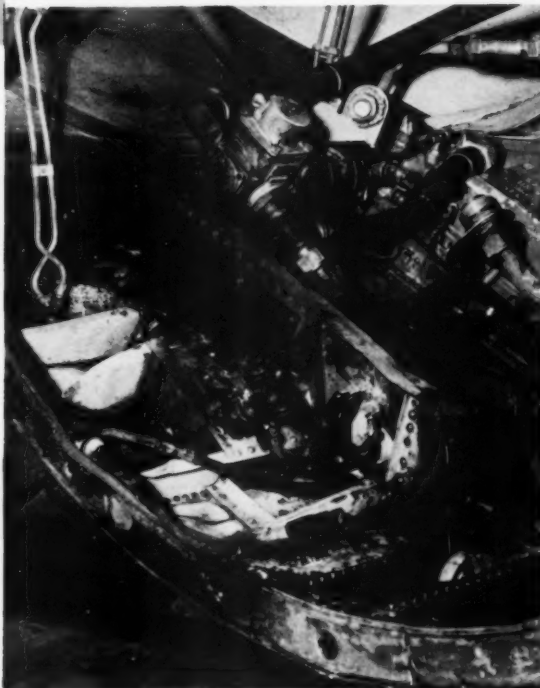
Hydraulic hose failure led to fire and explosion damaging fuselage of the Cougar during preparation for takeoff.

BuWeps message 252025Z of August 1960 NOTAL recommended replacement of the hose which failed in this incident with high pressure hose and directed replacement as soon as possible but not later than the next intermediate inspection after receipt of parts.

It should be noted that the failure which initiated replacement action by BuWeps involved rust in the hose wire braid. No evidence of rust was evident on the failed hose which caused this incident.
